Roadway Damage

Roadway Damage from Subsidence at San Manuel Mine

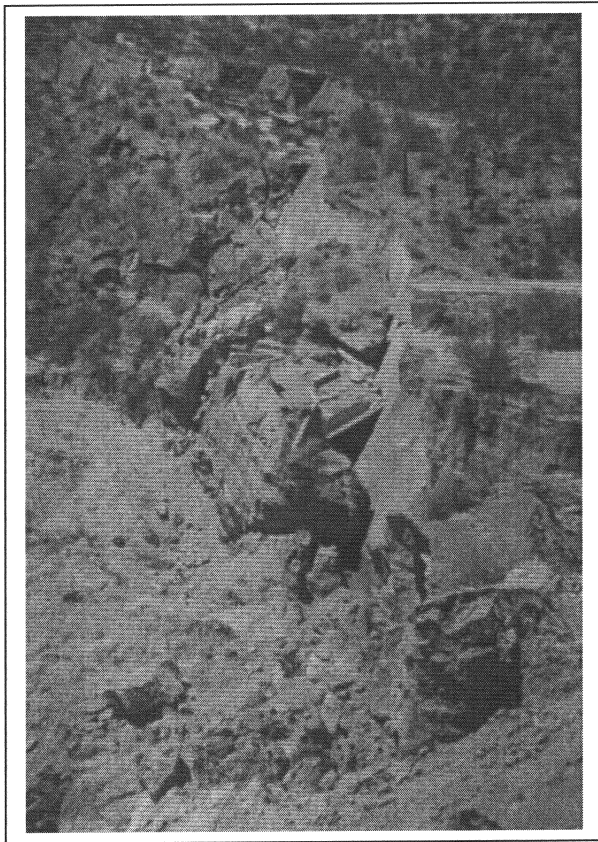
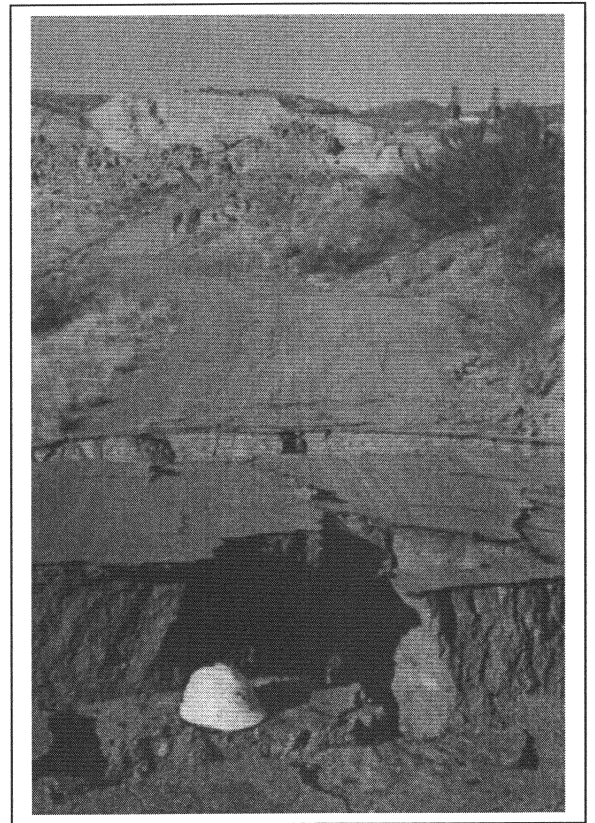
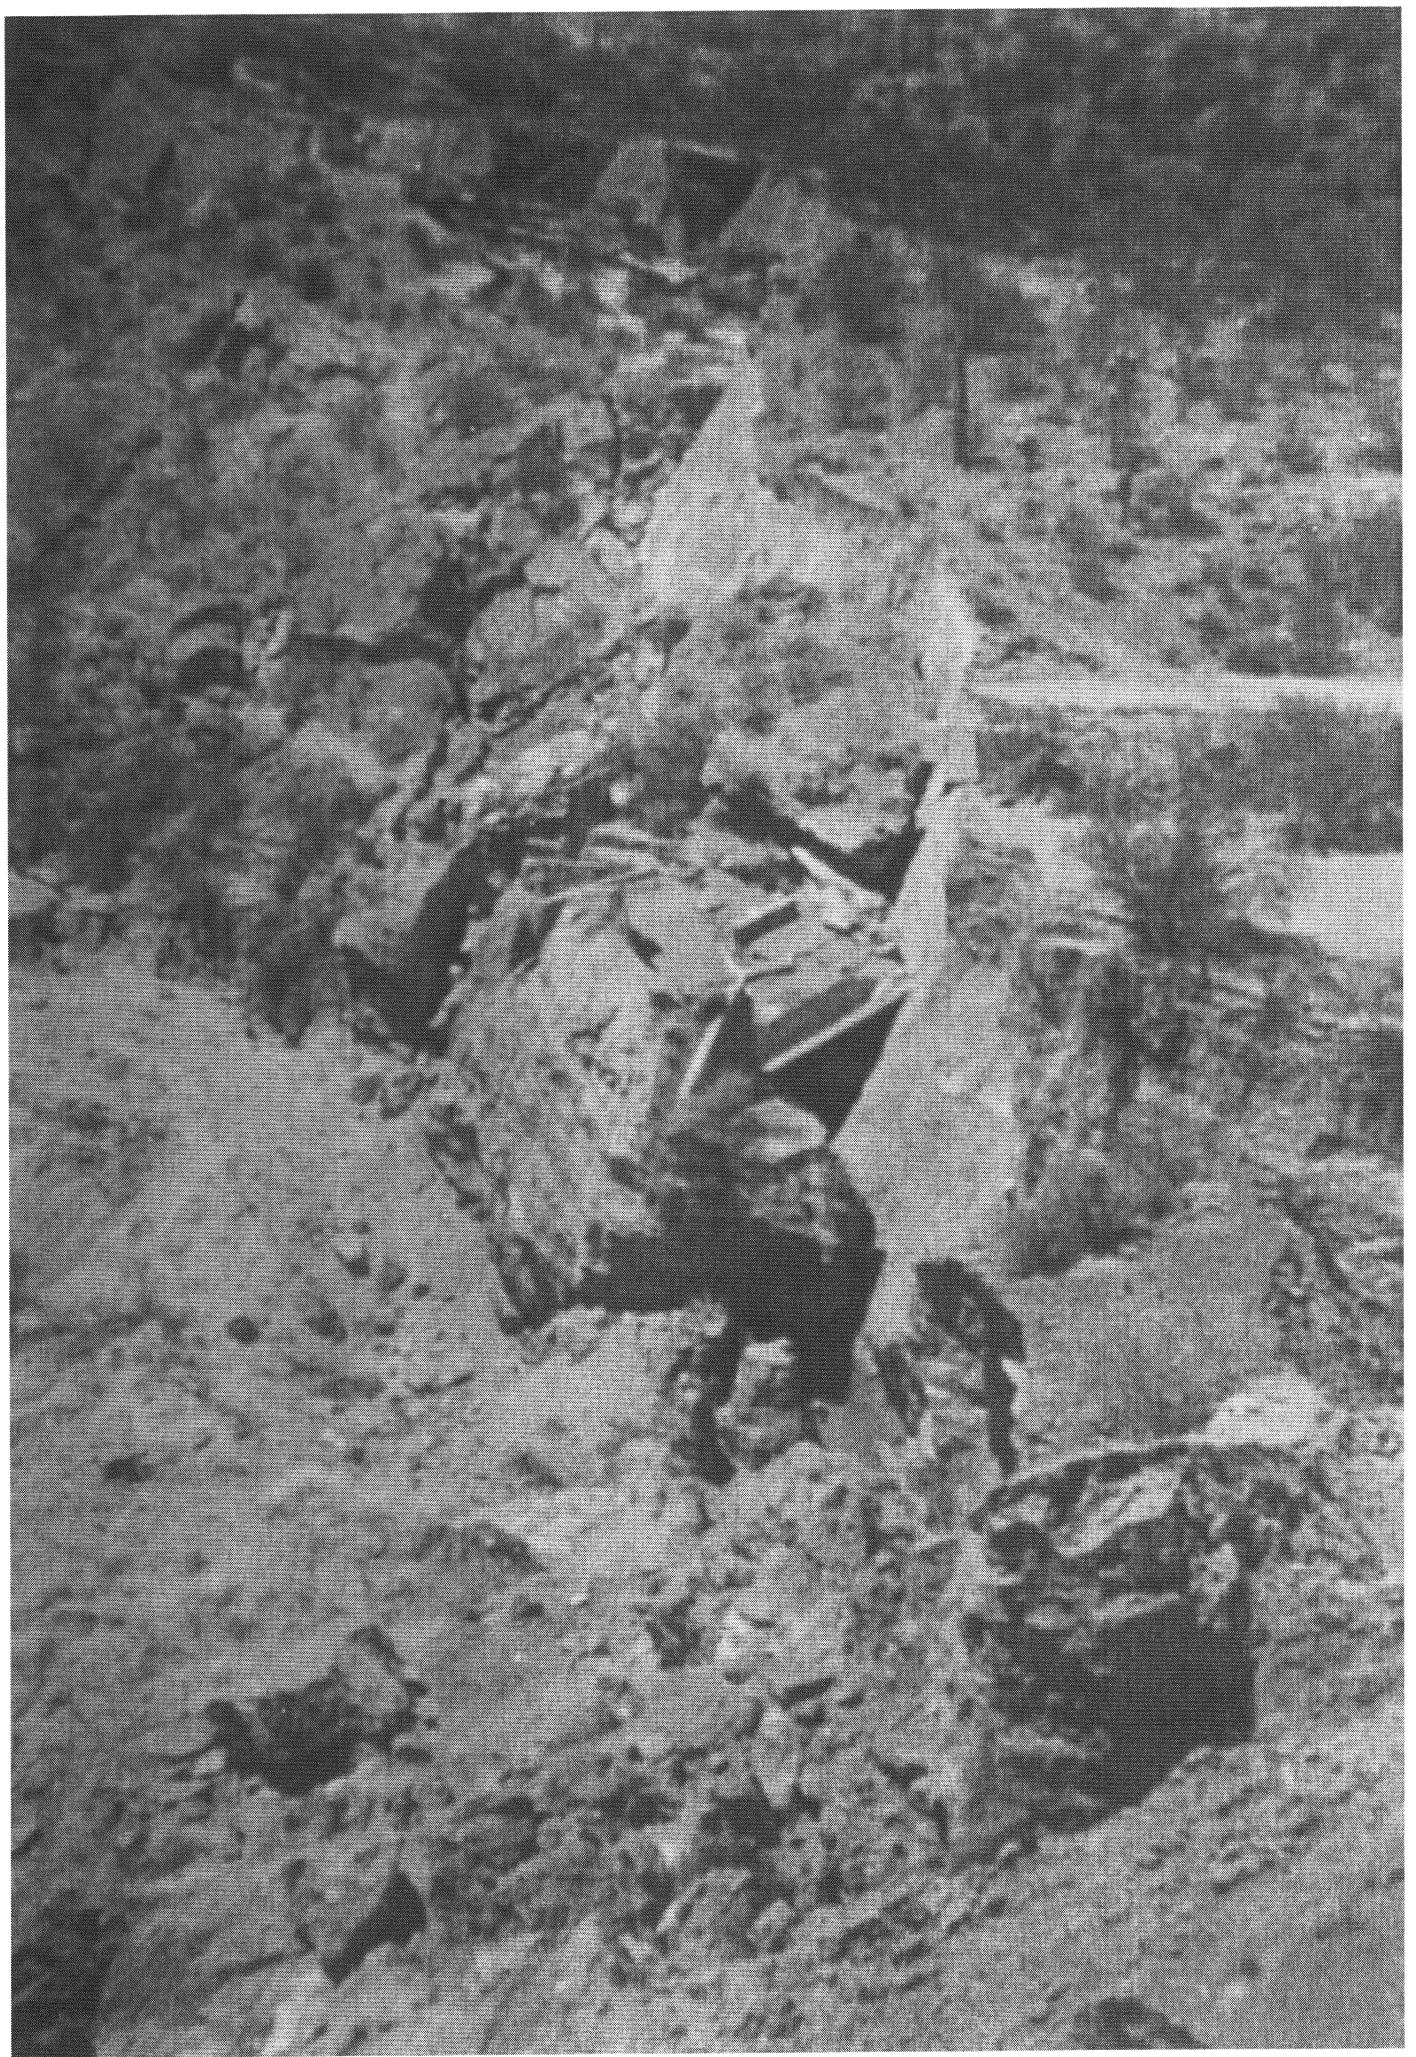
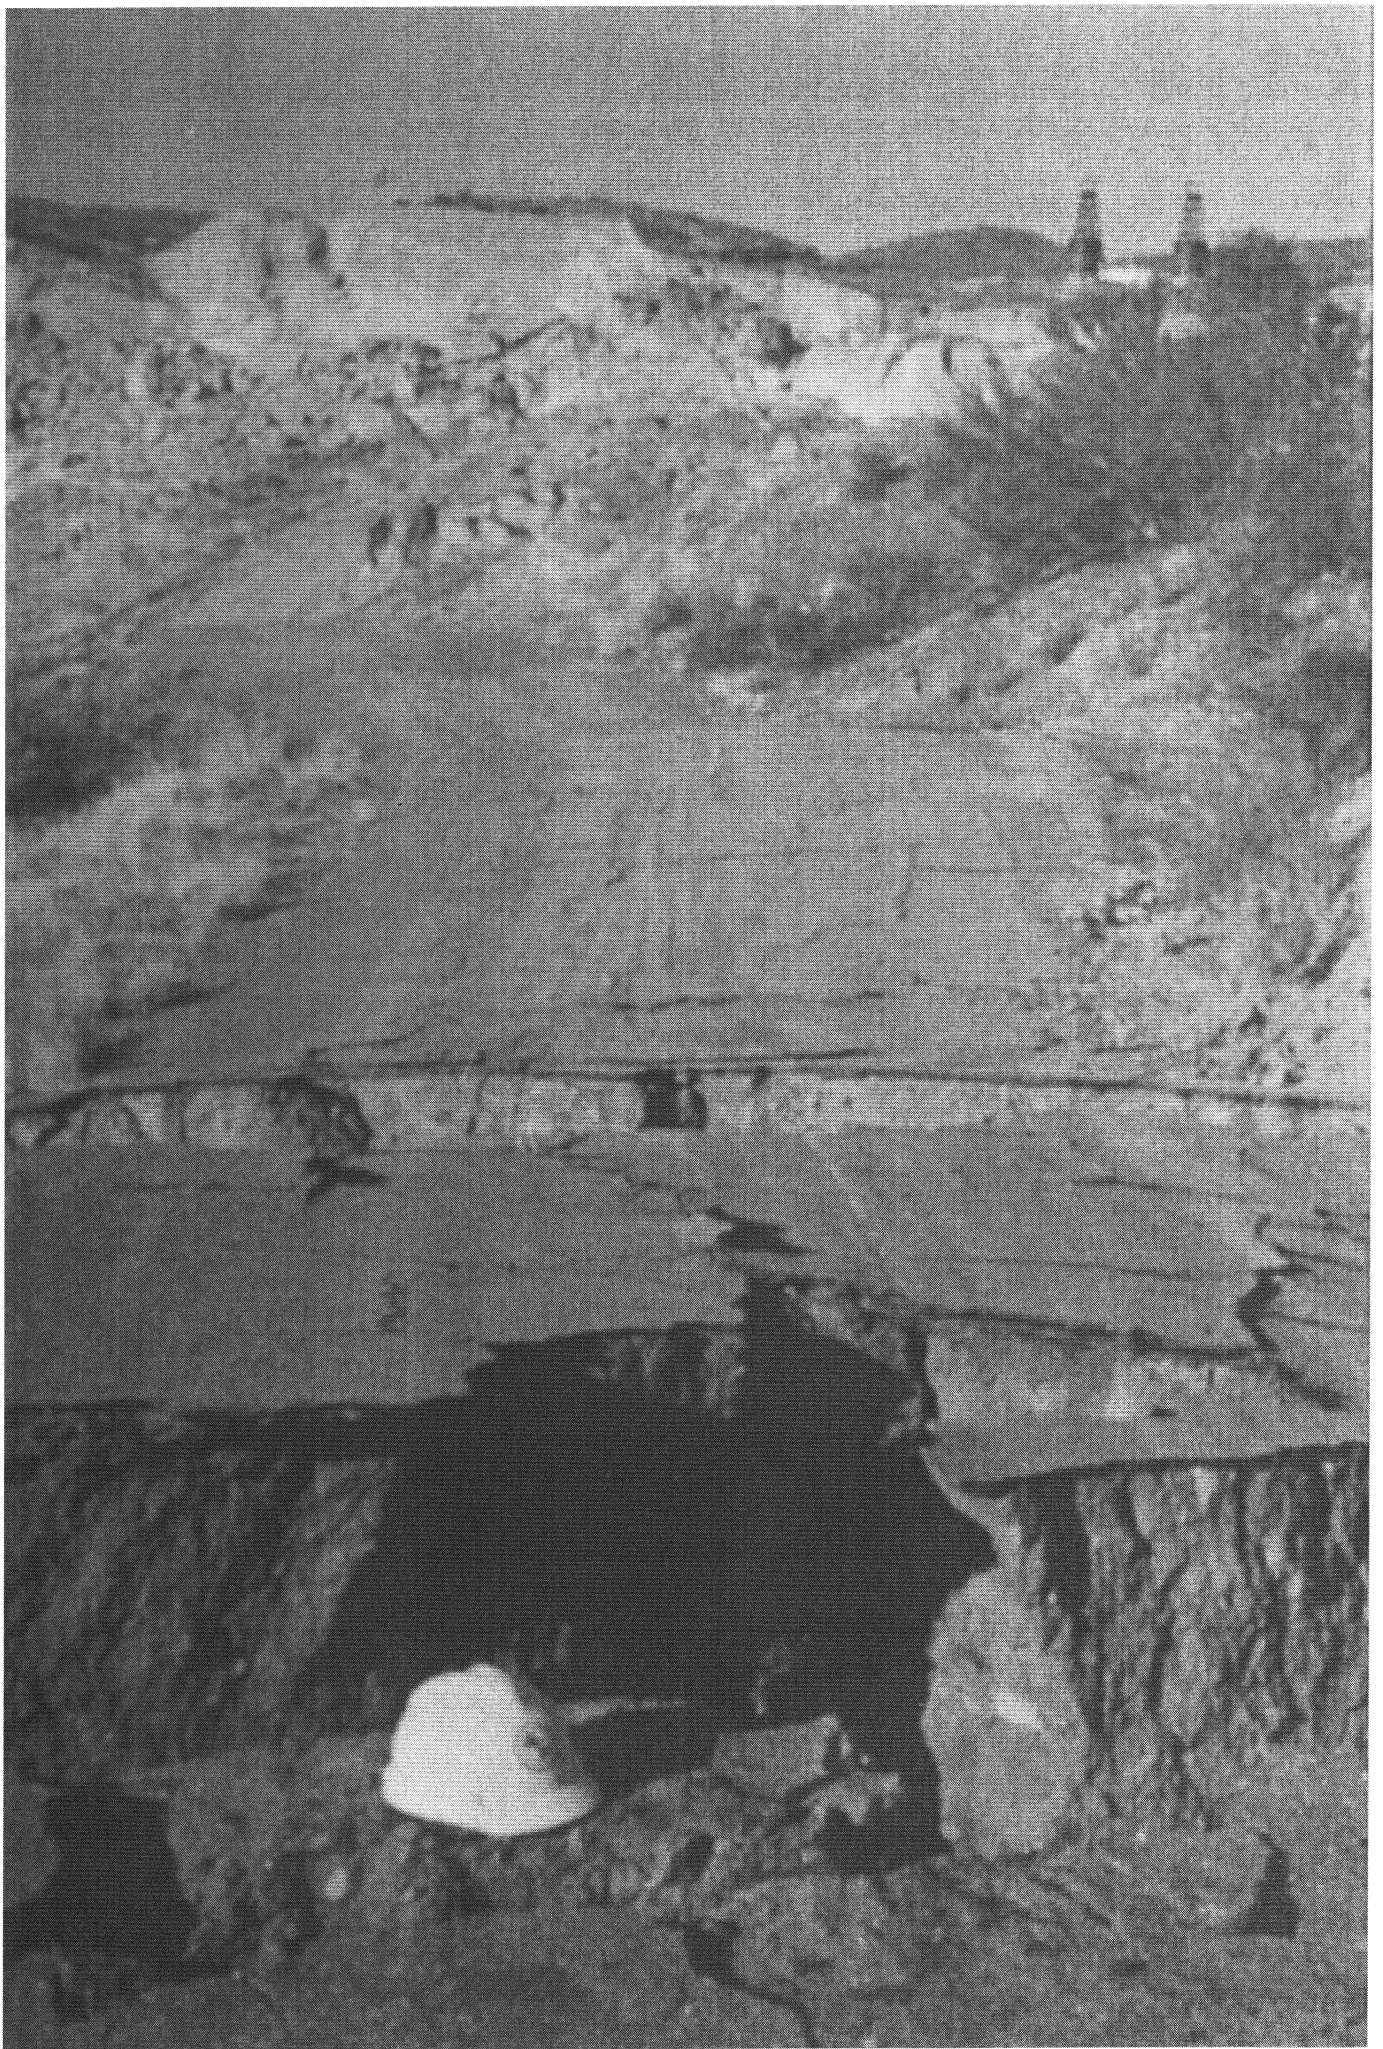
The following images display the destruction of small bridge on the former alignment of SR 77, at the edge of subsidence basin above the south ore body in 1965. The other images illustrate the destruction of pavement structure in the old highway alignment.
